Manhole Inspection Summary

Manhole # S15KK1015MH

Insp Date: **6/18/07 10:04 AM**

Location Address: **4405 FINEY AVE**

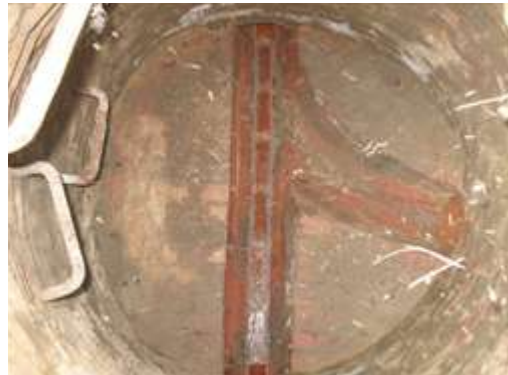
Top View

Corroded steps. Evidence of surcharge - Bench debris.

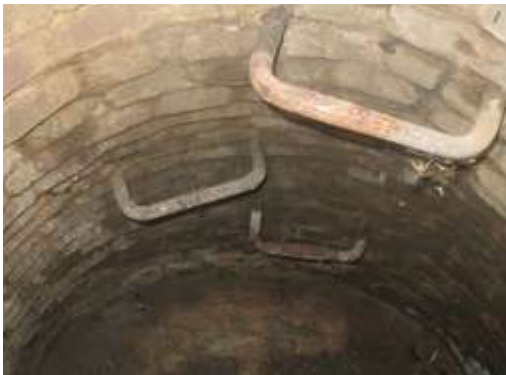
Defect

Corbel and Barrel infiltration.

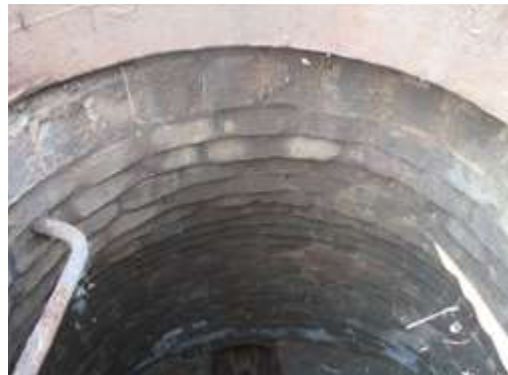
Defect

Frame leaks. Adjustment deterioration, root intrusion and infiltration. Corbel and Barrel infiltration.

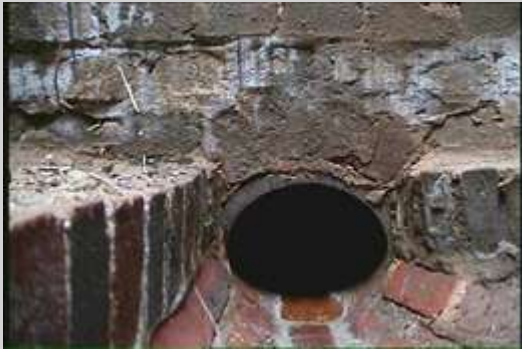
8 in. Circular Gravity Sewer Pipe Out @ 12 O'Clock

Infiltration: **Evidence** Pipe Seal Cond: **Unknown**

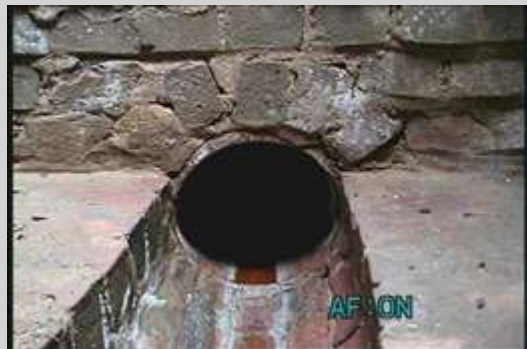
Pipe In @ 6 O'Clock

Infiltration: **Evidence**

Pipe Seal Cond: **Cracked**
